Technical Report on Ammunition Can Strap Verification

24 MARCH 2012

U.S. Army Tank Automotive Research,
Development, and Engineering Center
Detroit Arsenal
Warren, Michigan 48397-5000

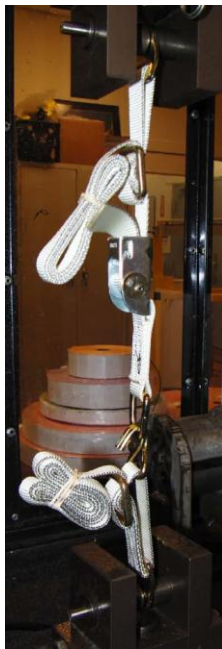
Our Lab was equipped to perform the test as described by PM-MRAP. The original set-up for the tests was done vertically as shown in Figure 1.

Figure 1. Sturge's original Test set-up

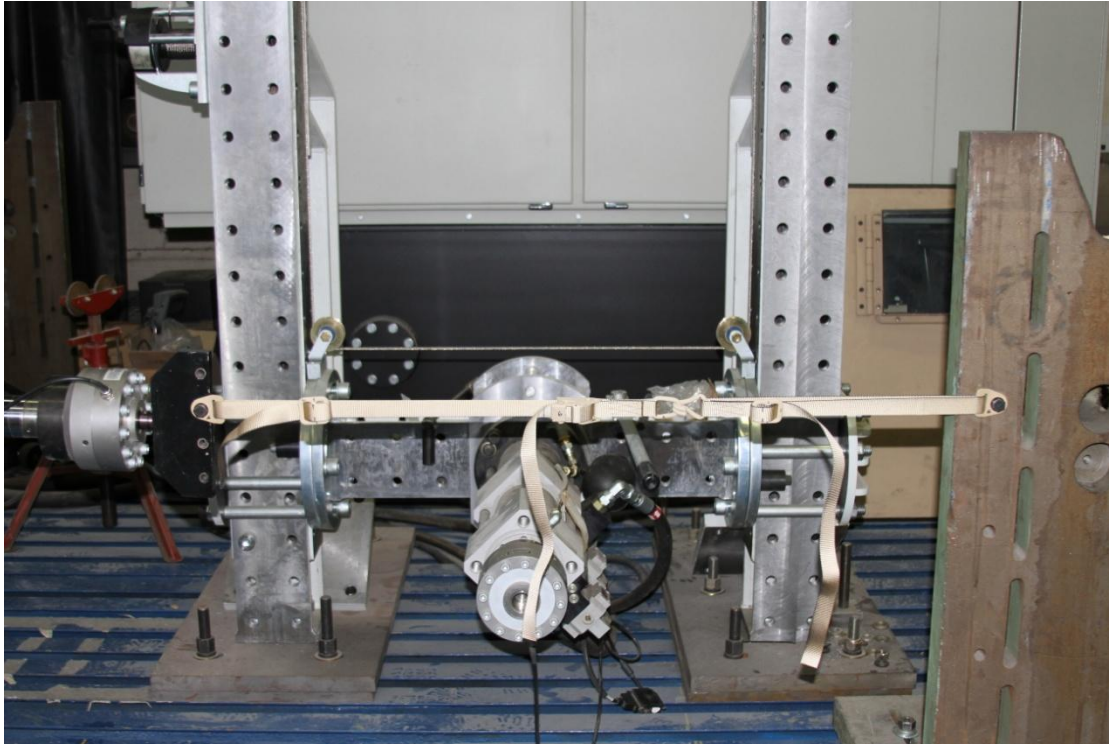
The tests as performed at TARDEC would be performed horizontally in a similar fashion. This was considered acceptable due to the part being placed in tension, gravity would not be a factor. TARDEC's set-up is shown below in Figure 2.

Figure 2. TARDEC Test Set-up

The test method that was used was gained straight from the contractor's test reports. The strap was harnessed on both ends at the "D" rings and a pull test was performed at a constant rate of 5"/Min.

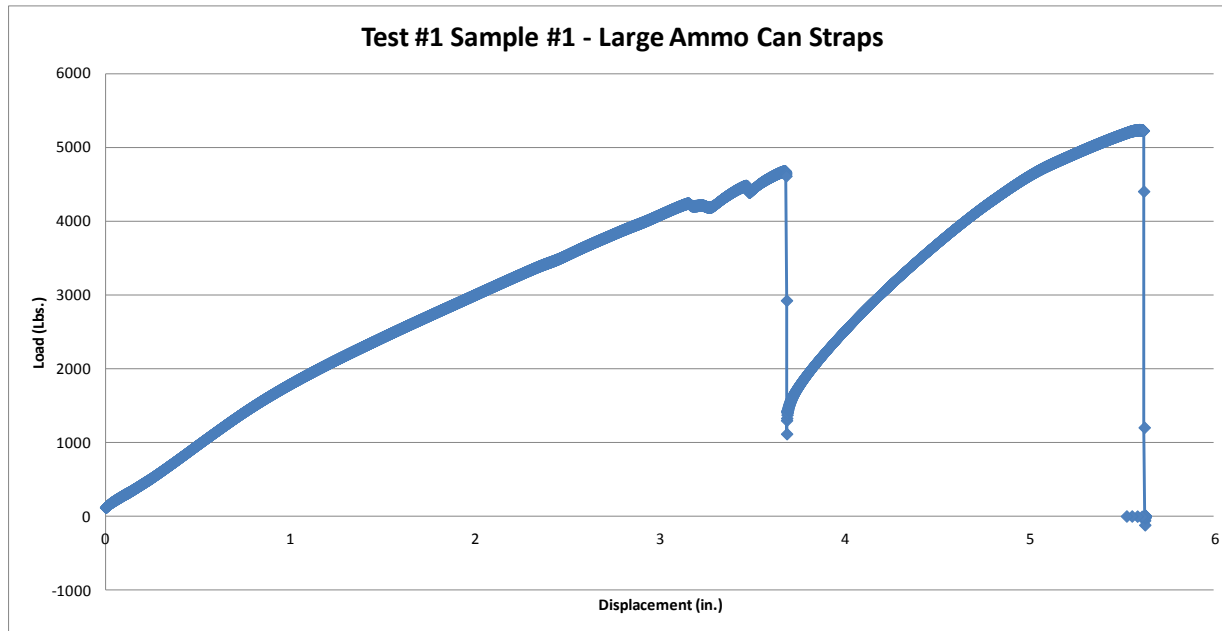
Belt Preload: 119.4 lbs.

Figure 3. Graph for Test 1(Large Straps).

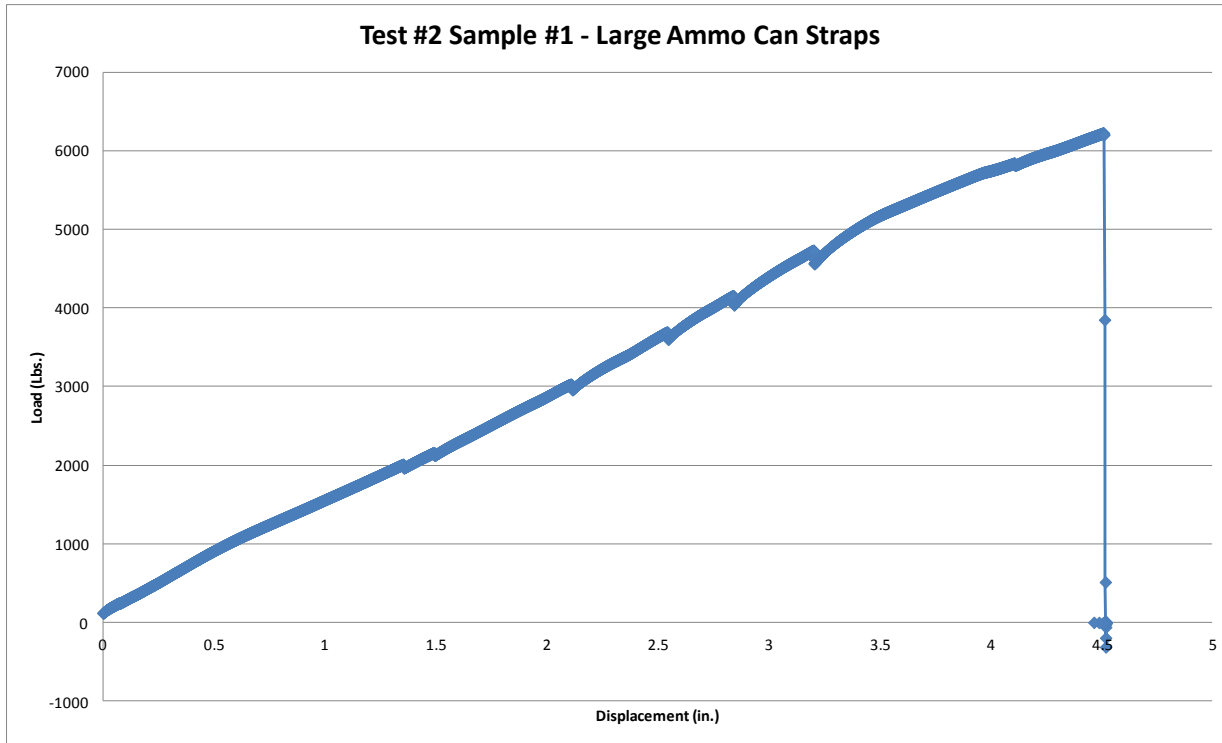
Belt Preload: 120.7 lbs.

Figure 4. Graph for Test 2(Large Straps).

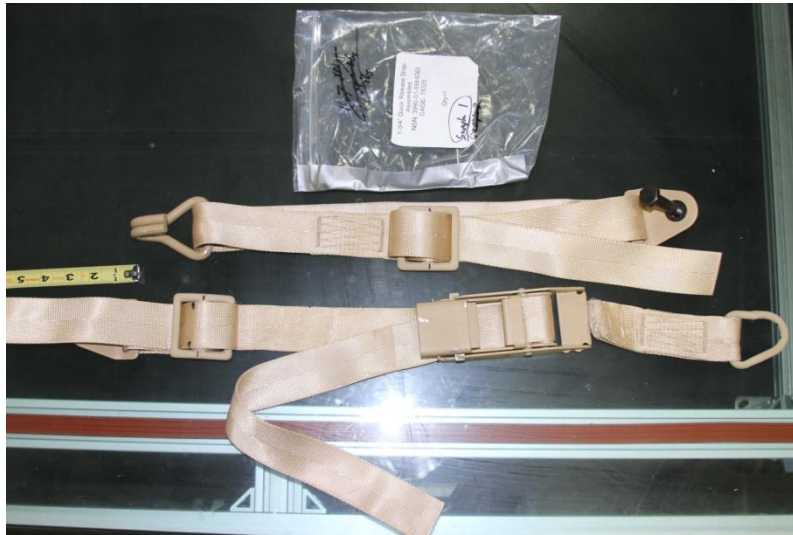
Figure 5. Sample 1 After Failure.

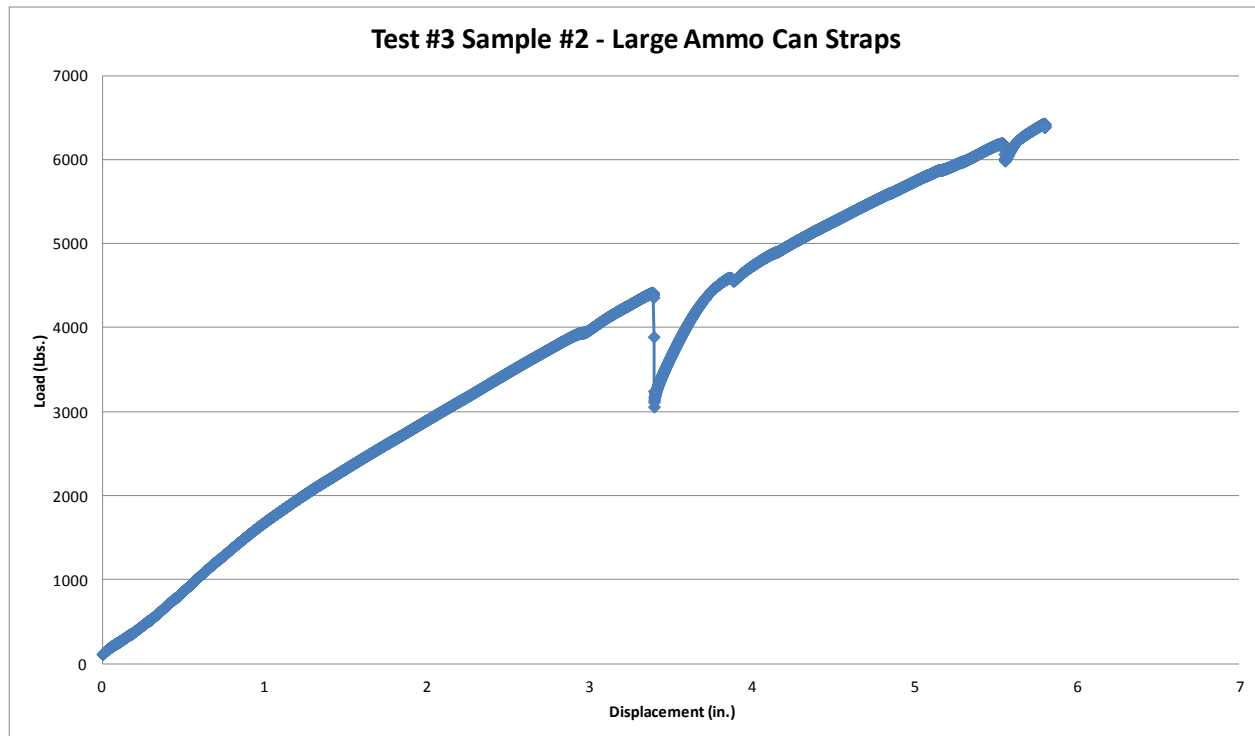
Belt Preload: 115.25 lbs.

Figure 6. Graph for Test 3(Large Straps).

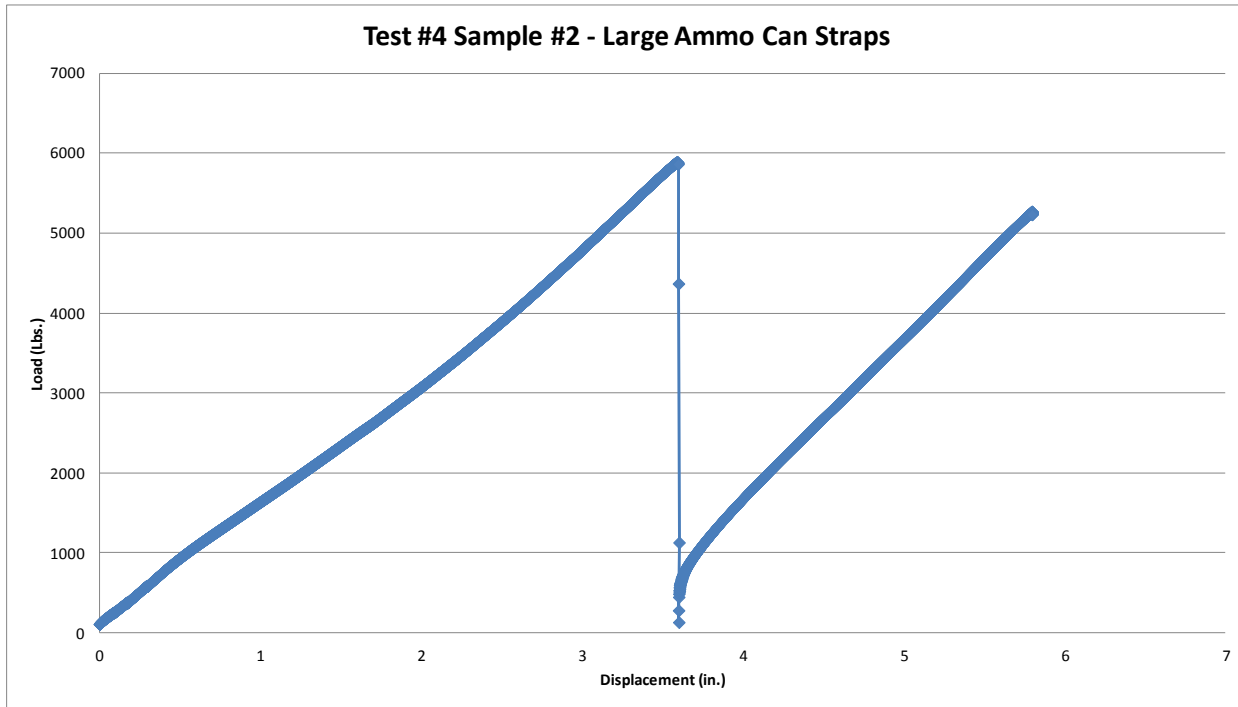
Belt Preload: 109.8 lbs.

Figure 7. Graph for Test 4(Large Straps).

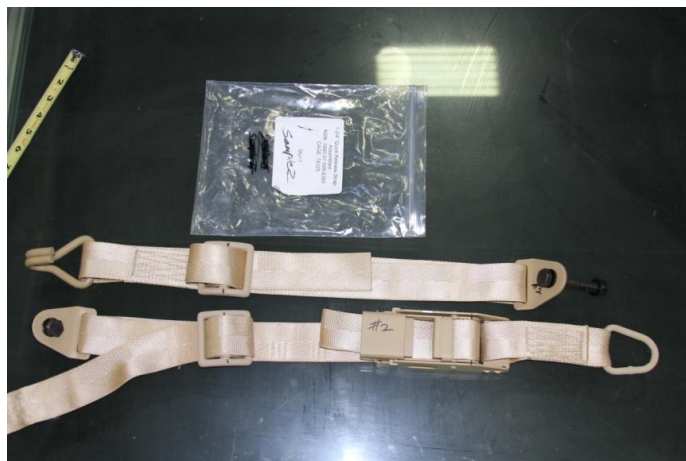
Figure 8. Sample 2 After Failure.

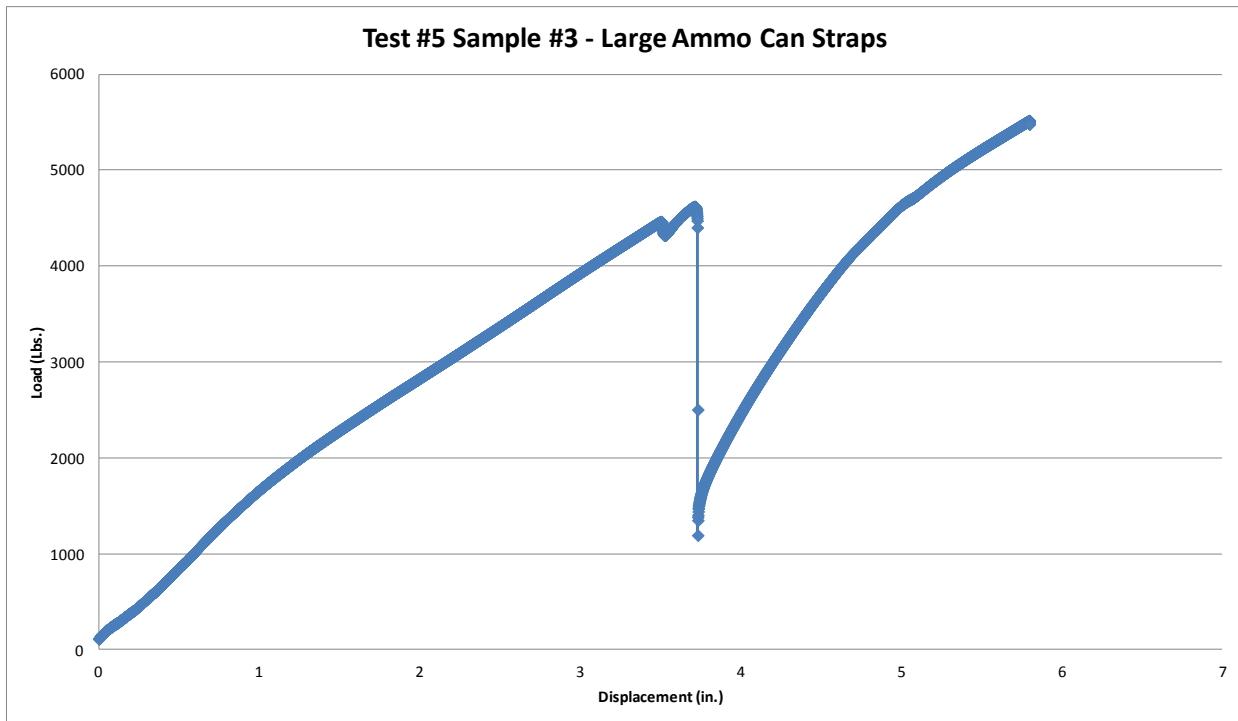
Belt Preload: 112.5 lbs.

Figure 9. Graph for Test 5(Large Straps).

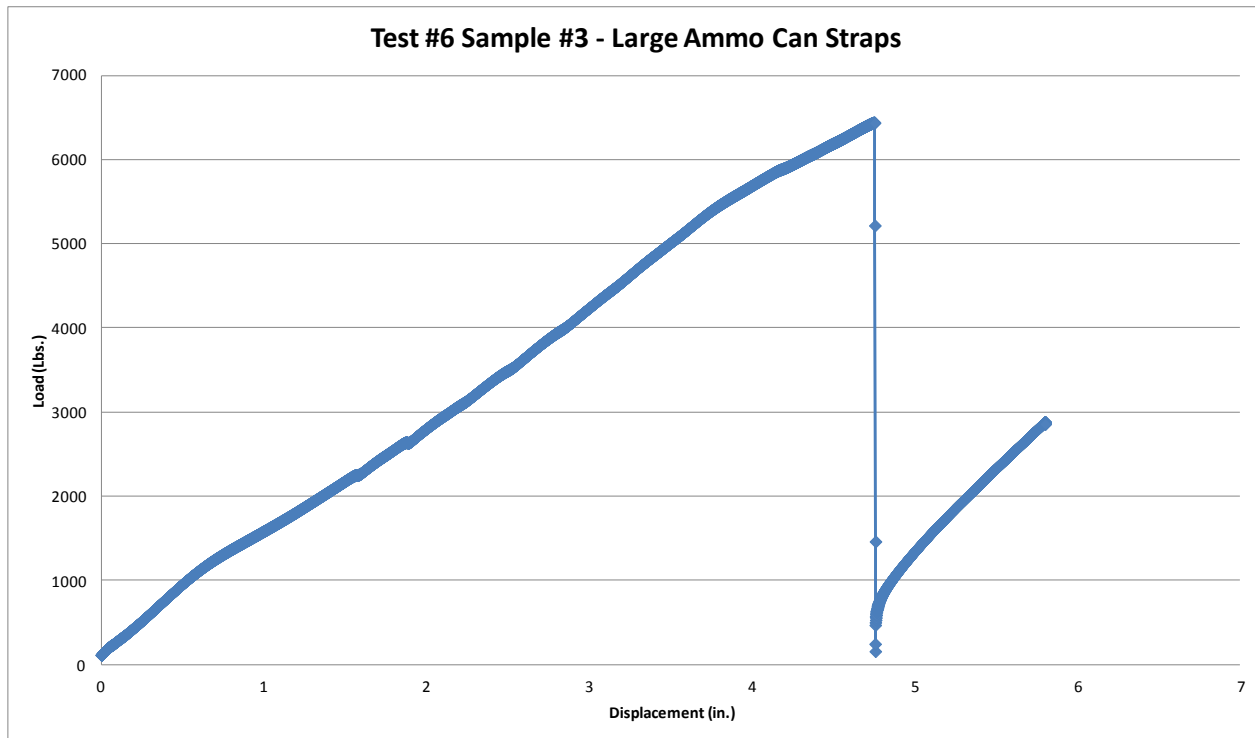
Belt Preload: 112.5 lbs.

Figure 10. Graph for Test 6(Large Straps).

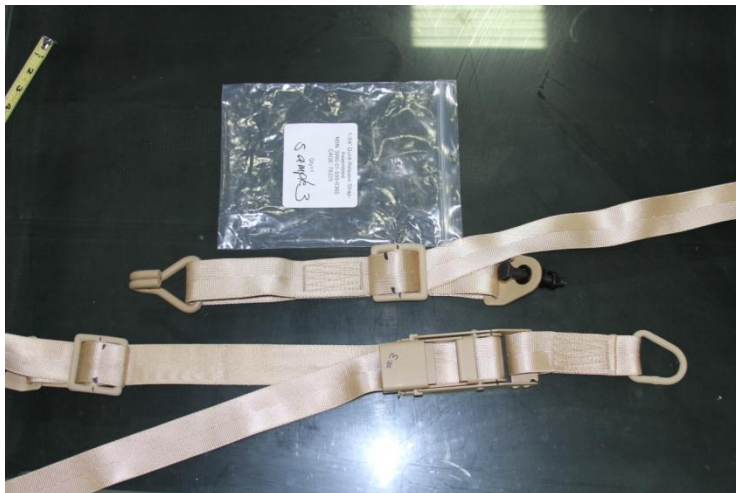
Figure 11. Sample 3 After Failure.

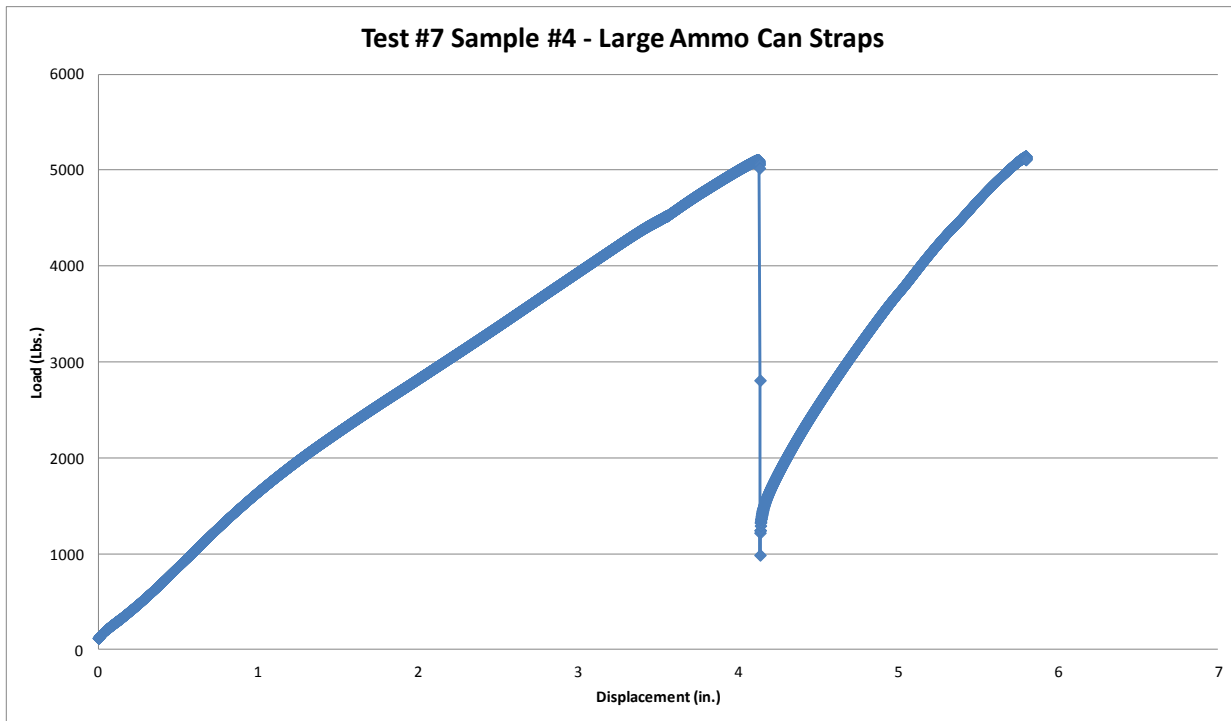
Belt Preload: 120.7 lbs.

Figure 12. Graph for Test 7(Large Straps).

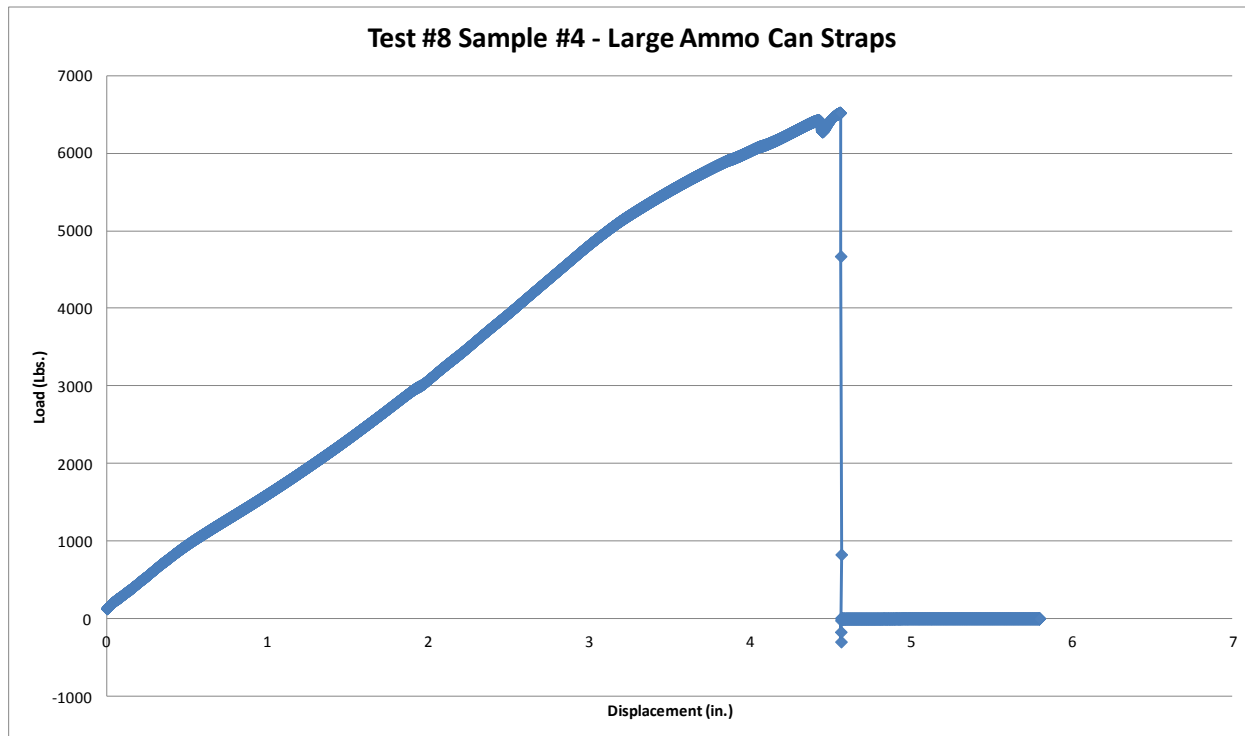
Belt Preload: 133.1 lbs.

Figure 13. Graph for Test 8(Large Straps).

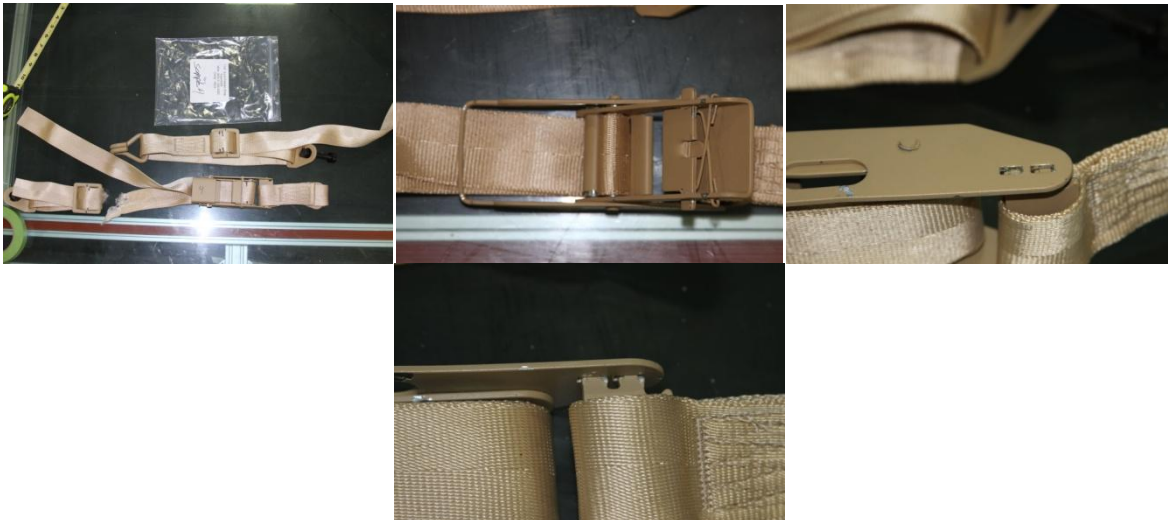
Figure 14. Sample 4 After Failure – Latching hardware failed.

1. The large straps had multiple failure points. This is a concern from a safety and from a quality standpoint. From a safety point it is better to drive the failure to consistently occur at a single point of the design. The resultant failures occurring at multiple points could be caused by a design issue or manufacturing quality issue. The resultant parts may not be manufactured with sufficient quality.

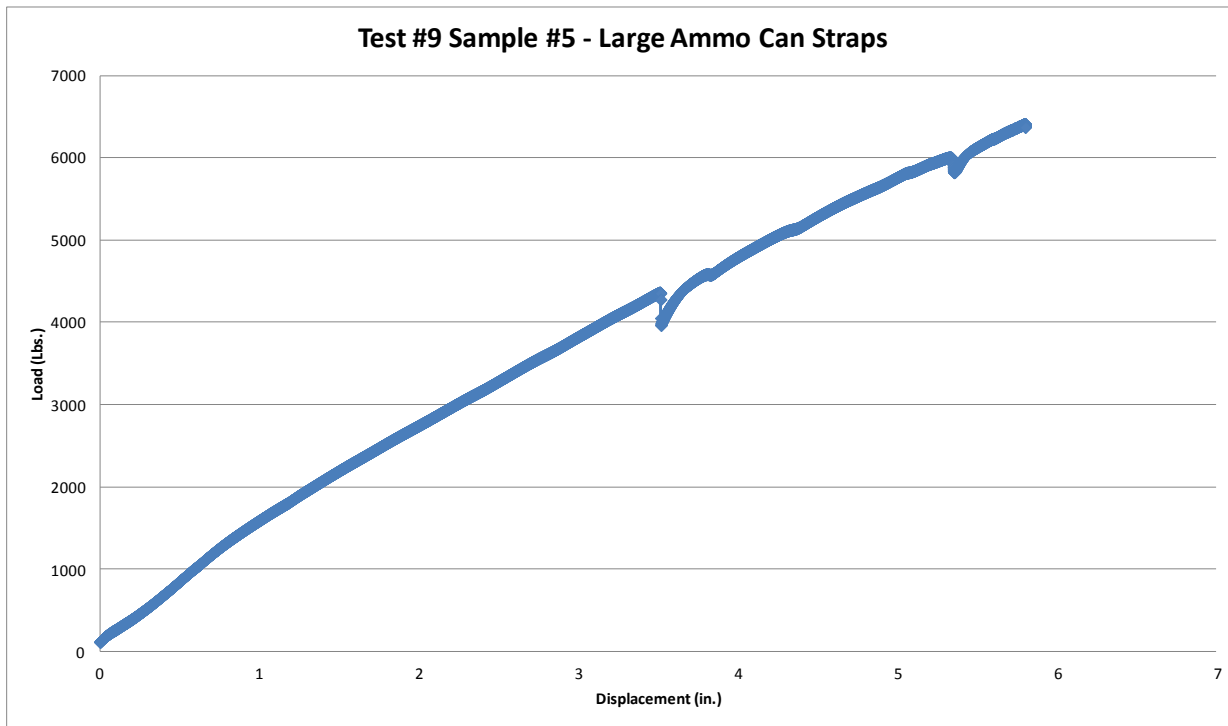
Belt Preload: 116.6 lbs.

Figure 15. Graph for Test 9(Large Straps).

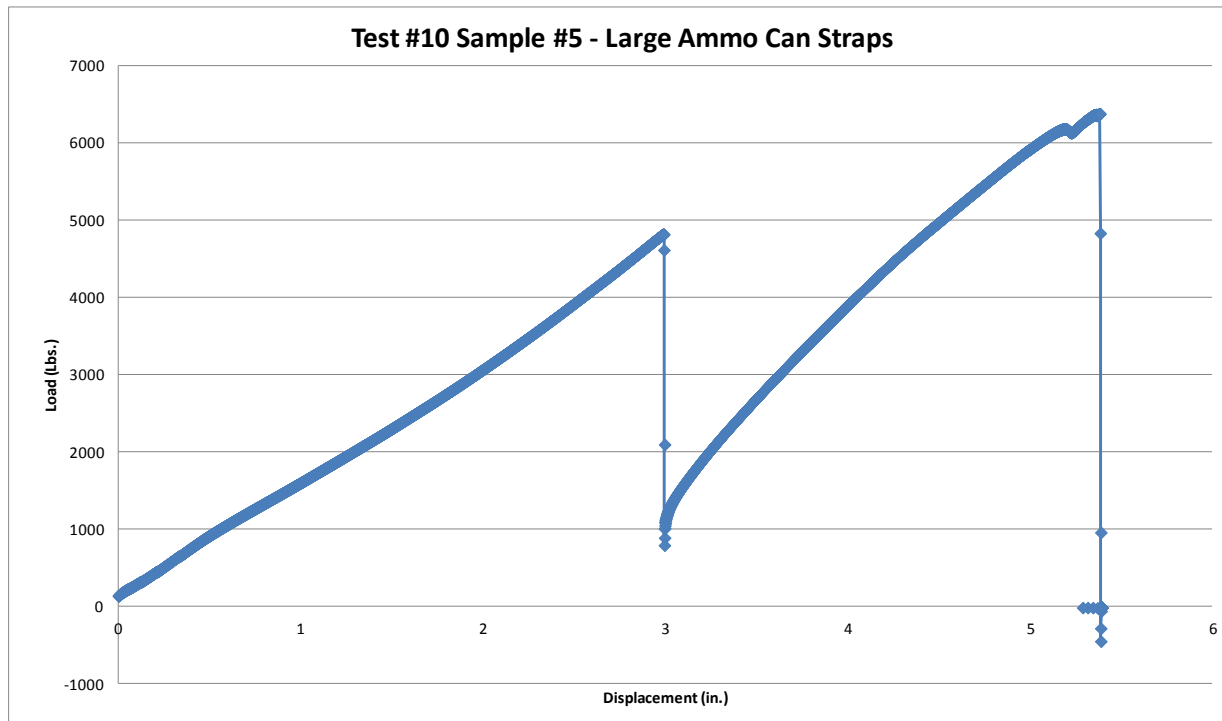
Belt Preload: 135.8 lbs.

Figure 16. Graph for Test 10(Large Straps).

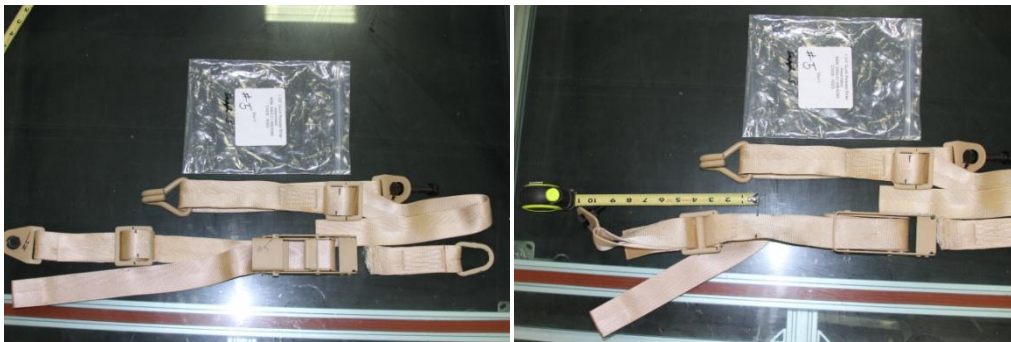
Figure 17. Sample 5 after failure.

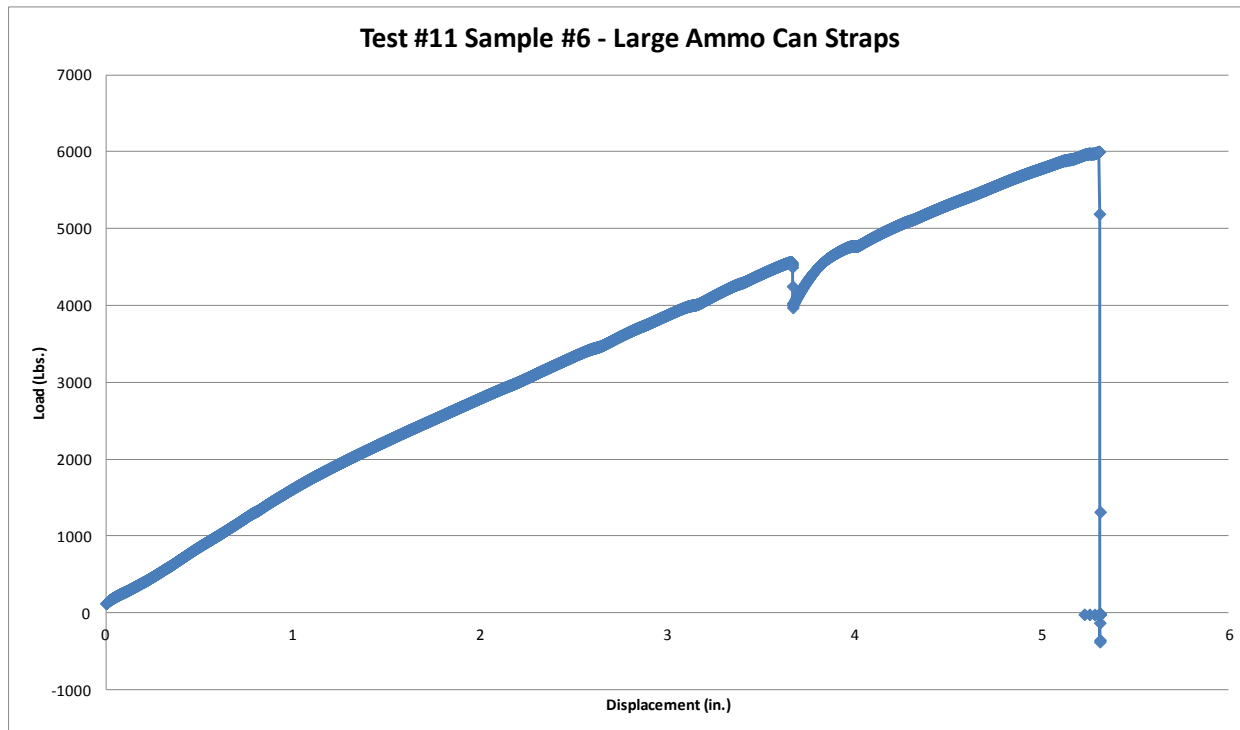
Belt Preload: 123.4 lbs.

Figure 18. Graph for Test 11(Large Straps).

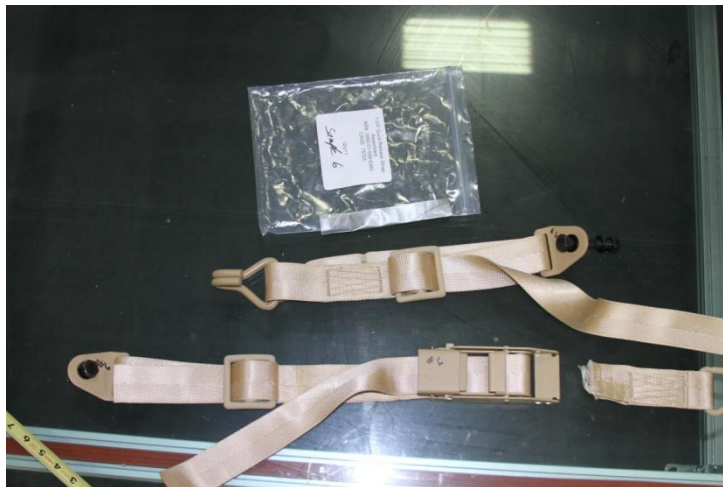
Figure 19. Sample 6 after failure.

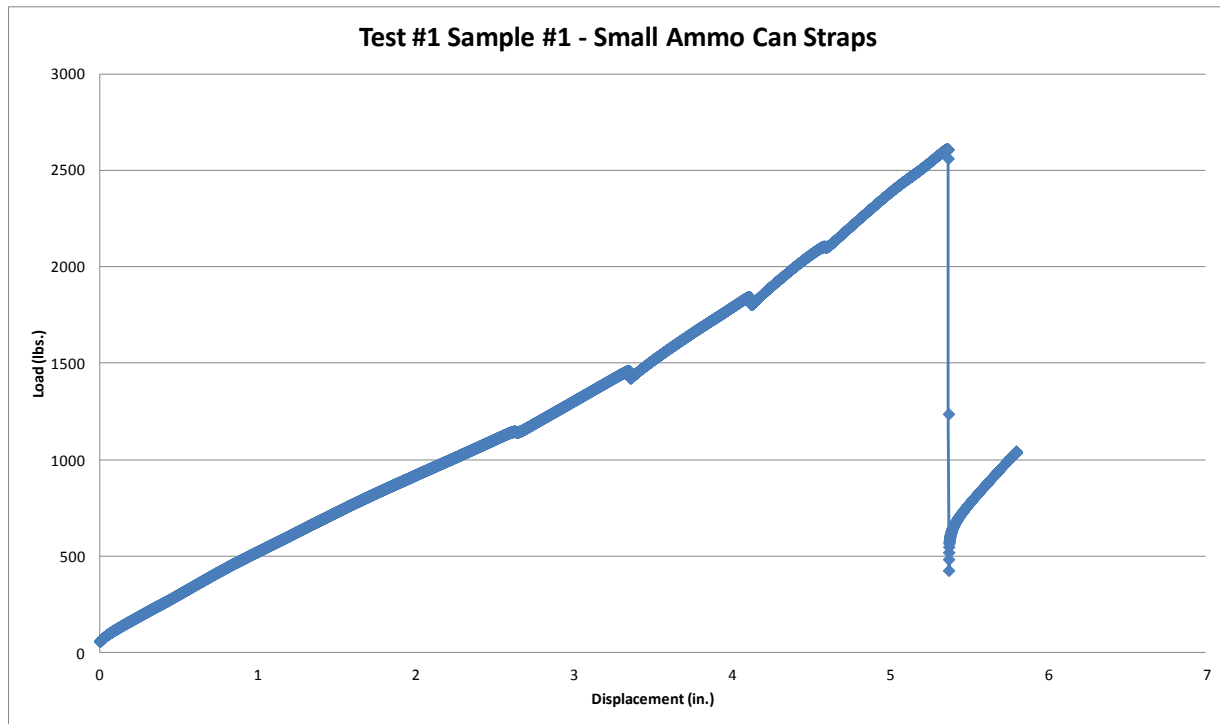
Belt Preload: 59 lbs.

Figure 20. Graph for Test 1 (Small Strap).

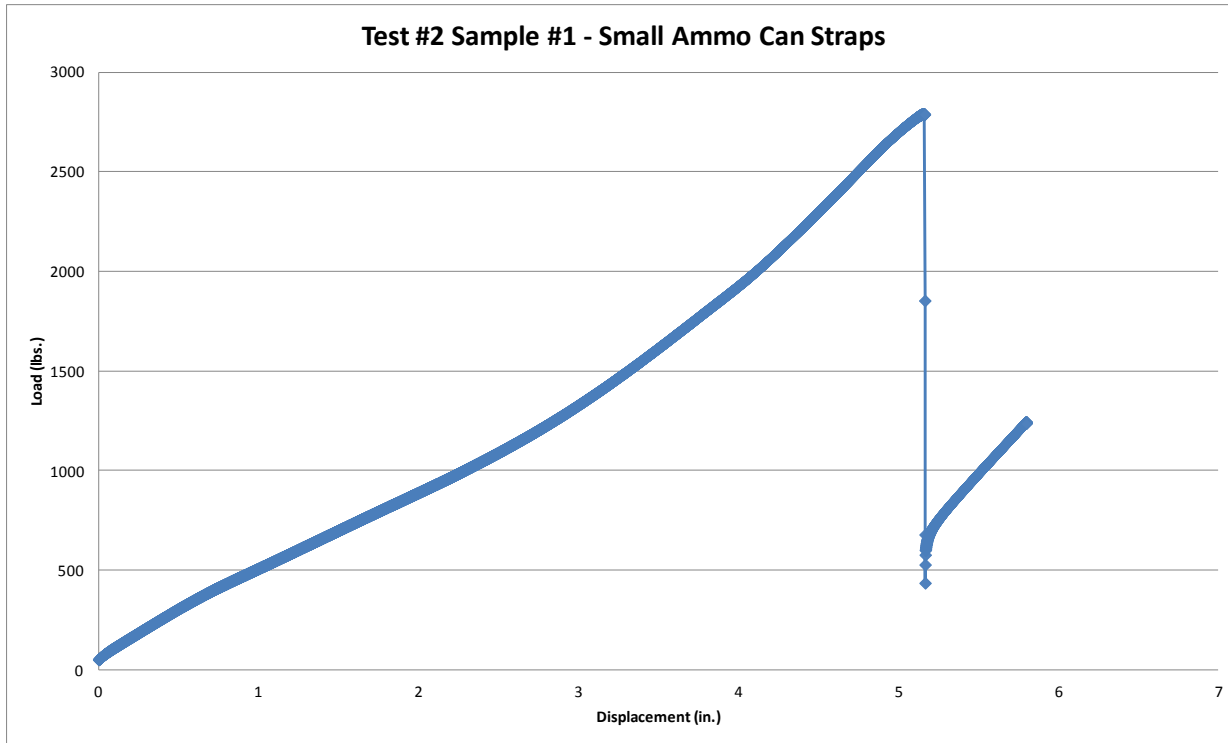
Belt Preload: 52 lbs.

Figure 21. Graph for Test 2 (Small Strap).

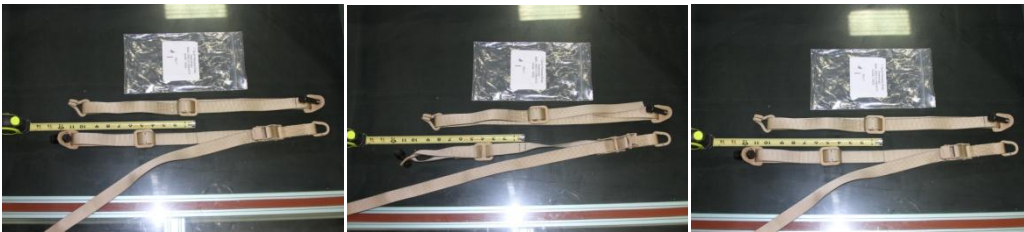
Figure 22. Sample 1 After Failure.

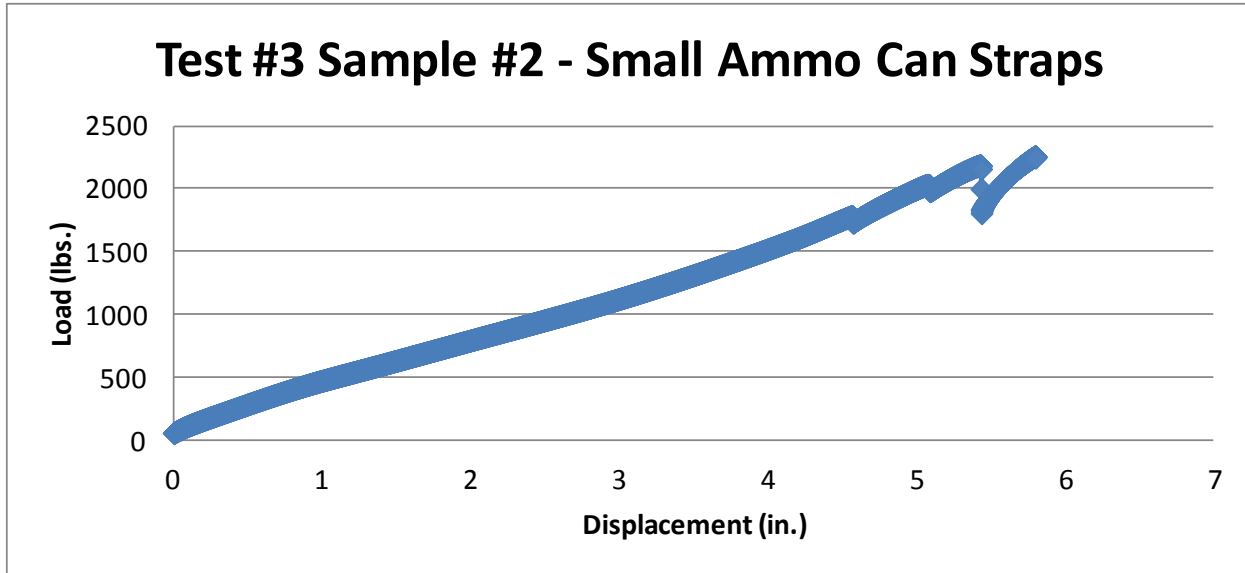
Belt Preload: 59 lbs.

Figure 23. Graph for Test 3 (Small Strap).

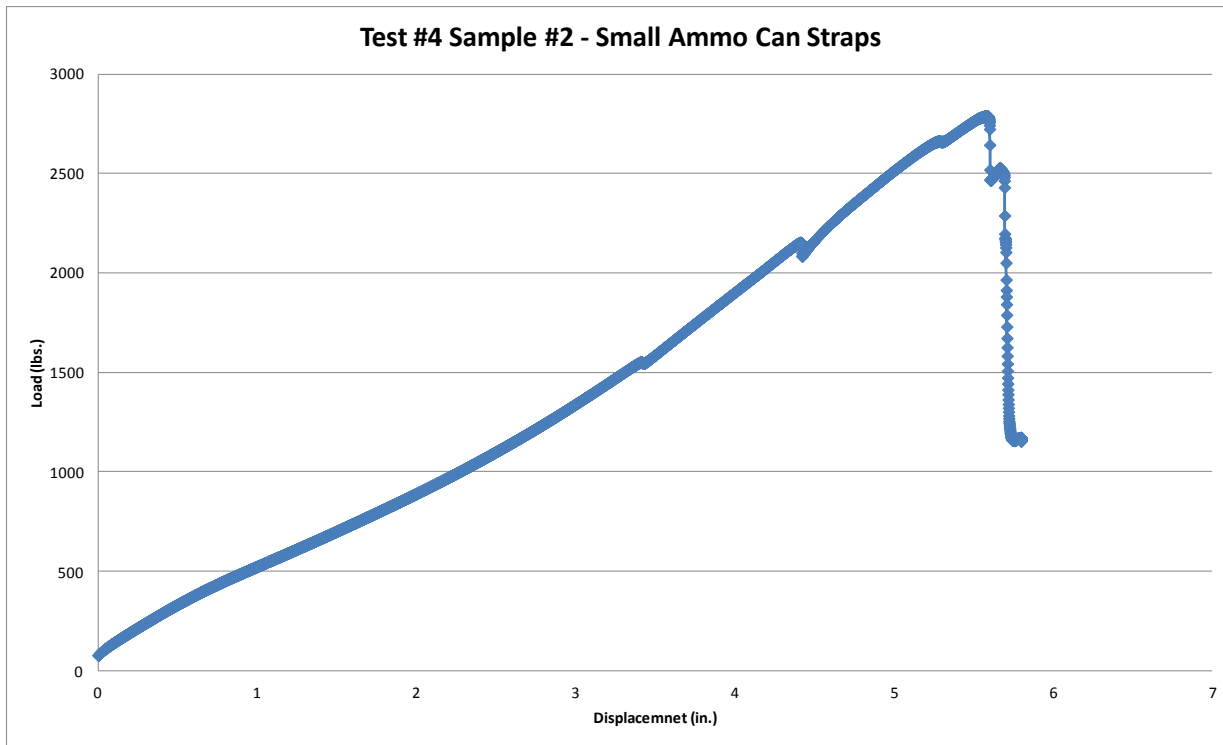
Belt Preload: 78 lbs.

Figure 24. Graph for Test 4 (Small Strap).

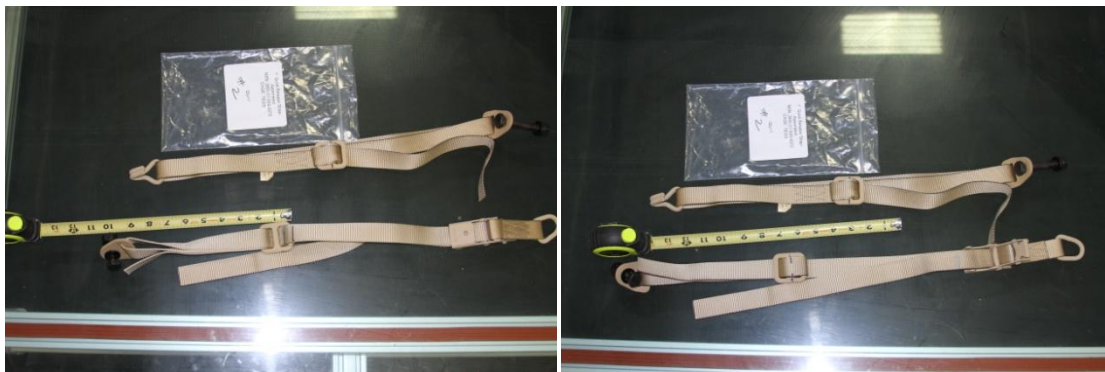
Figure 25. Sample 2 After Failure.

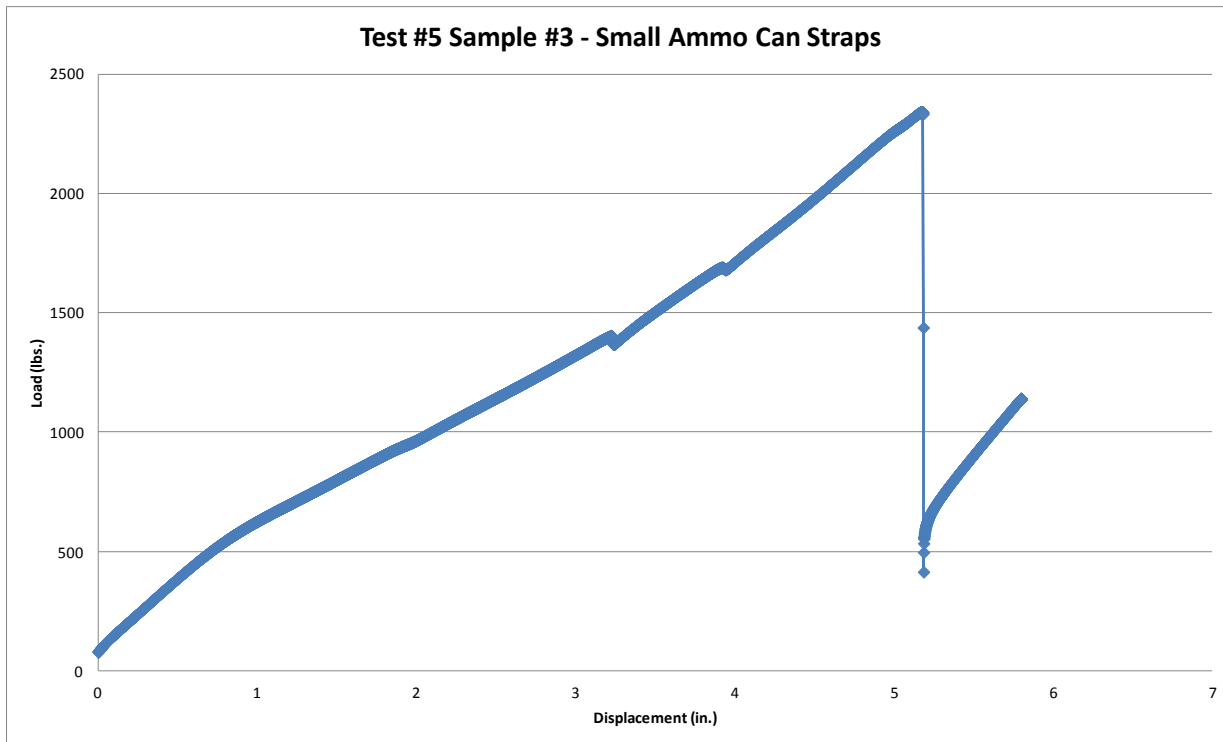
Belt Preload: 79 lbs.

Figure 26. Graph for Test 5 (Small Strap).

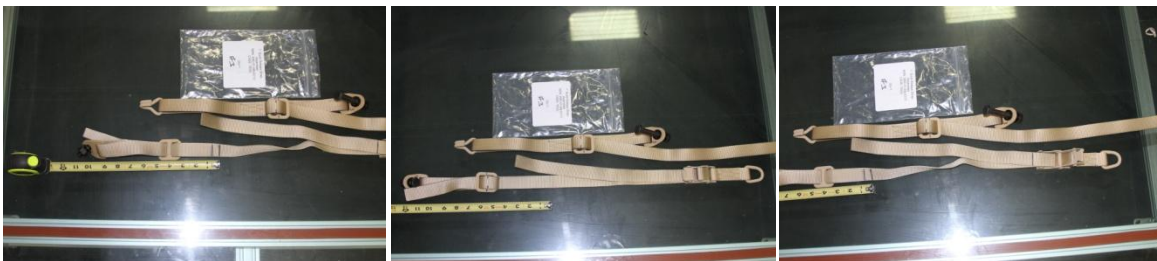
Figure 27. Sample 3 After Failure.

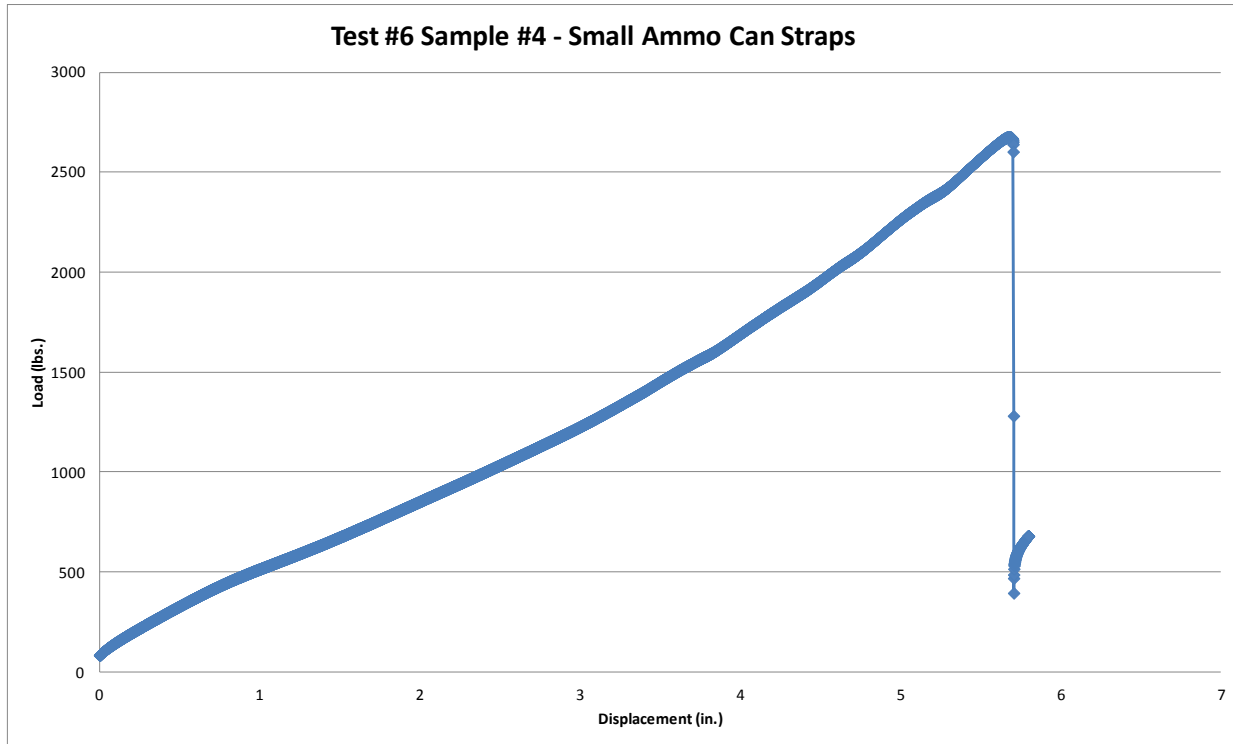
Belt Preload: 83.7 lbs.

Figure 28. Graph for Test 6 (Small Strap).

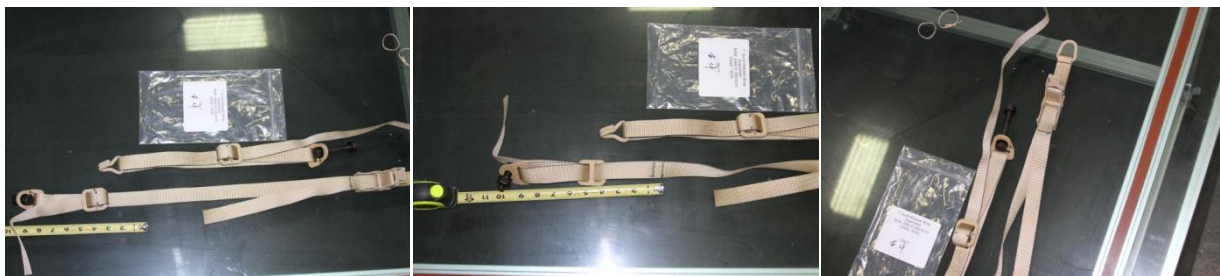
Figure 29. Sample 4 After Failure.

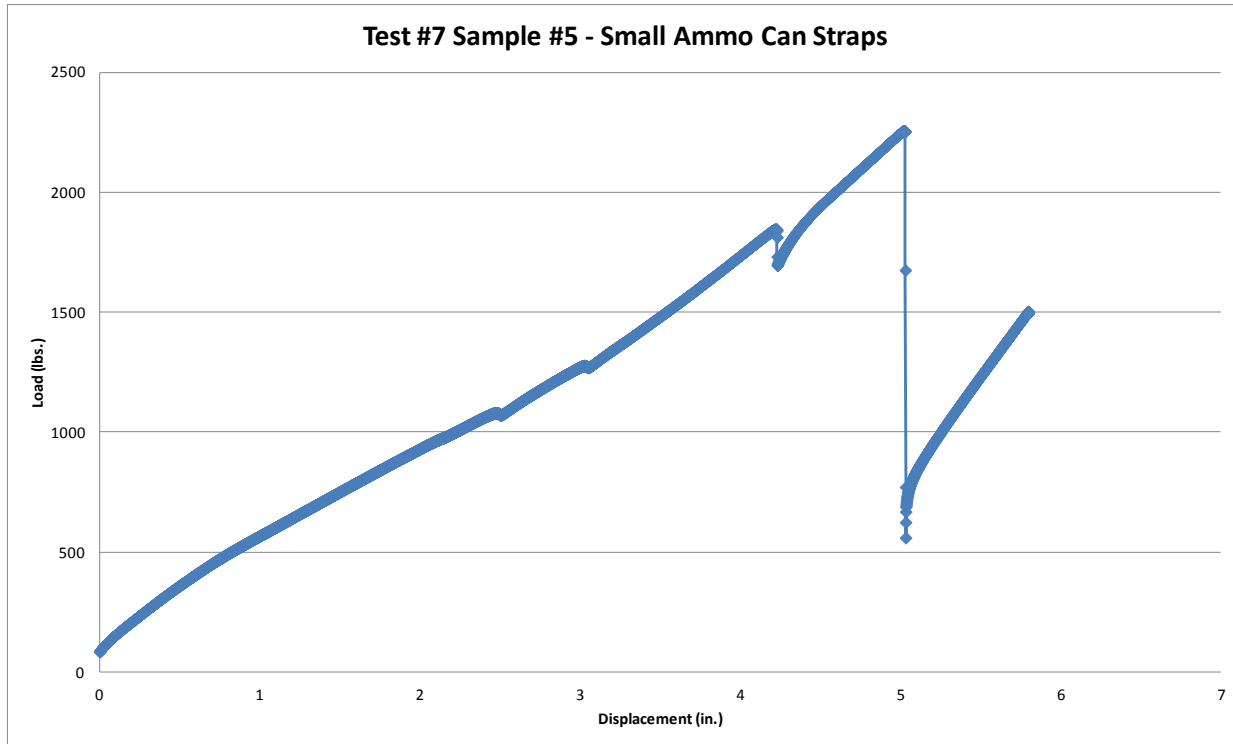
Belt Preload: 85.7 lbs.

Figure 30. Graph for Test 7 (Small Strap).

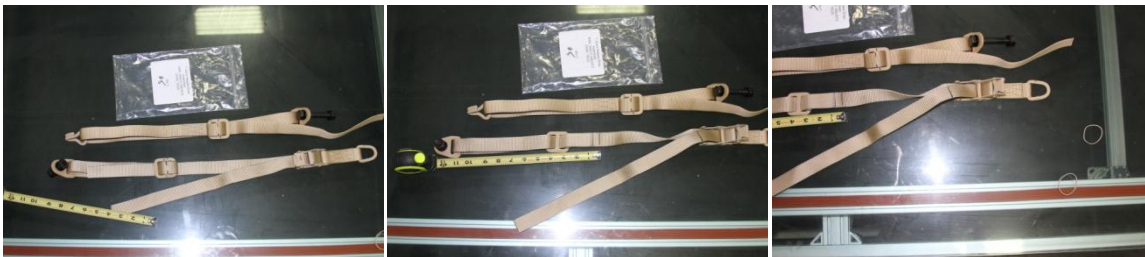
Figure 31. Sample 5 After Failure.

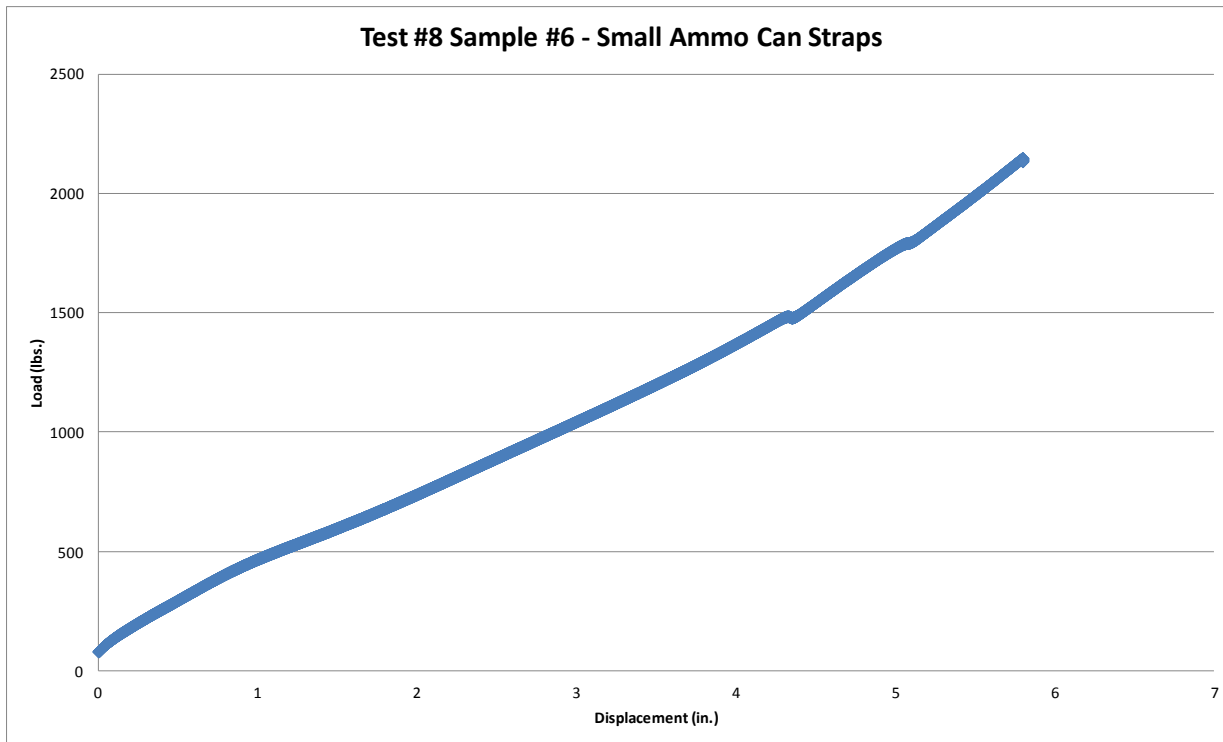
Belt Preload: 81 lbs.

Figure 32. Graph for Test 8 (Small Strap).

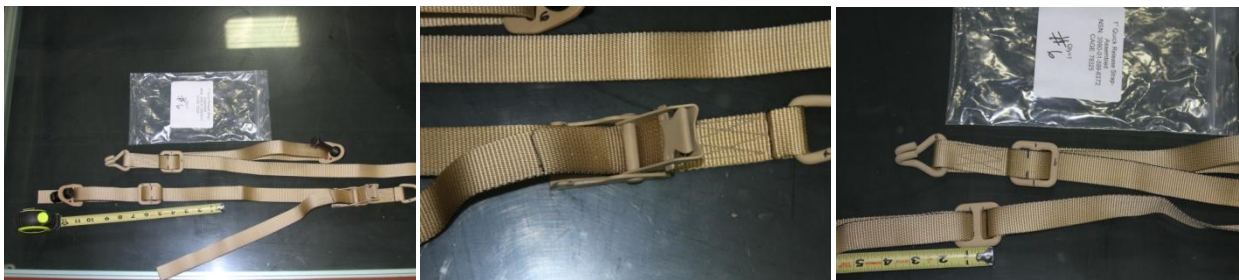
Figure 33. Sample 6 After Failure.
